# Thermal Building Inspection Report.

Property Address	Our Lady Star Of The Sea Church 204 Espanong Rd, Lake Hopatcong, NJ 07849
Client Name	Michael Kahwaty
Inspection Date	05/16/25
Inspection Conducted By	Paul Komosinski - Thermographer License #100892 - FAA Certified Drone Pilot License #4240003
Thermal Camera Model	DJI Mavic 3 Enterprise-Thermal
Weather Conditions	Slightly overcast, Fair, Wind 10 Mph.

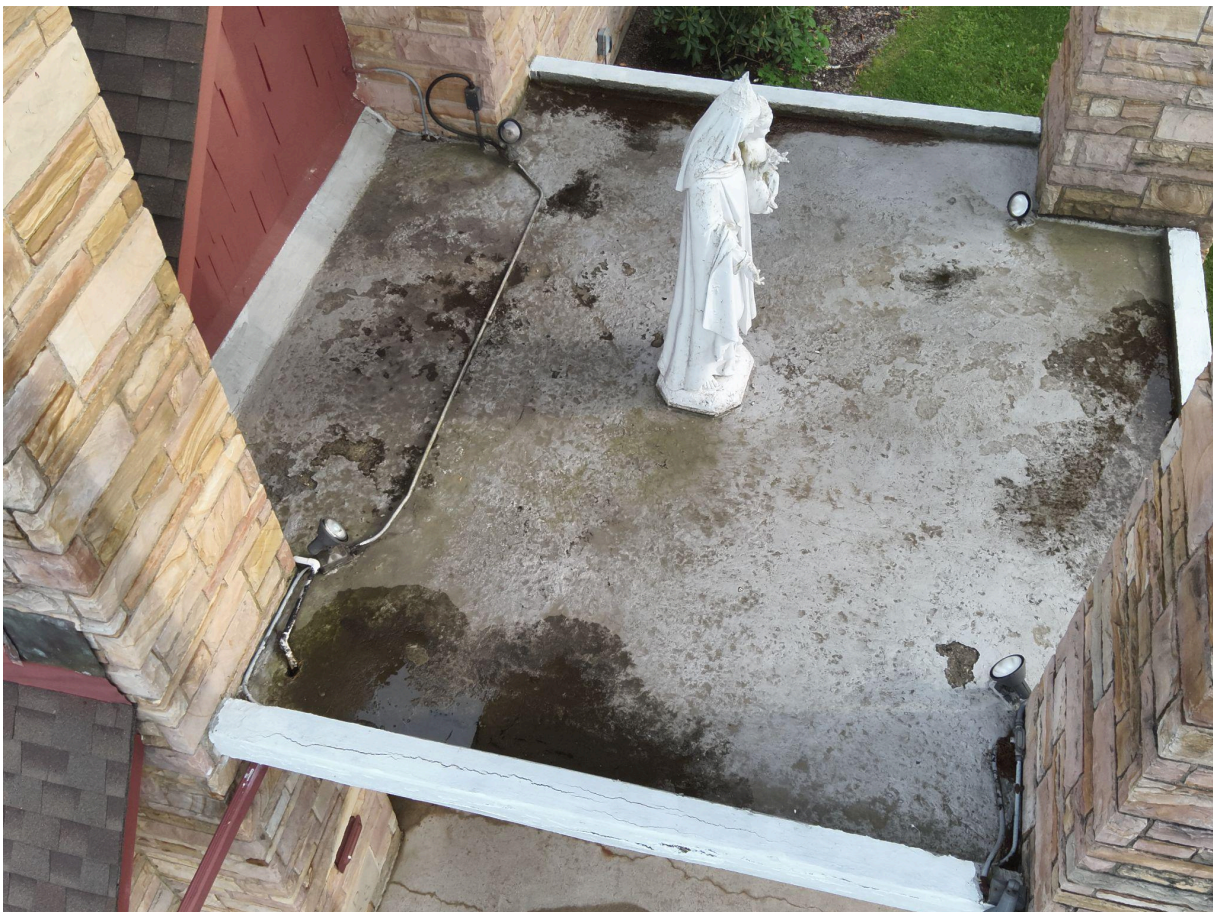
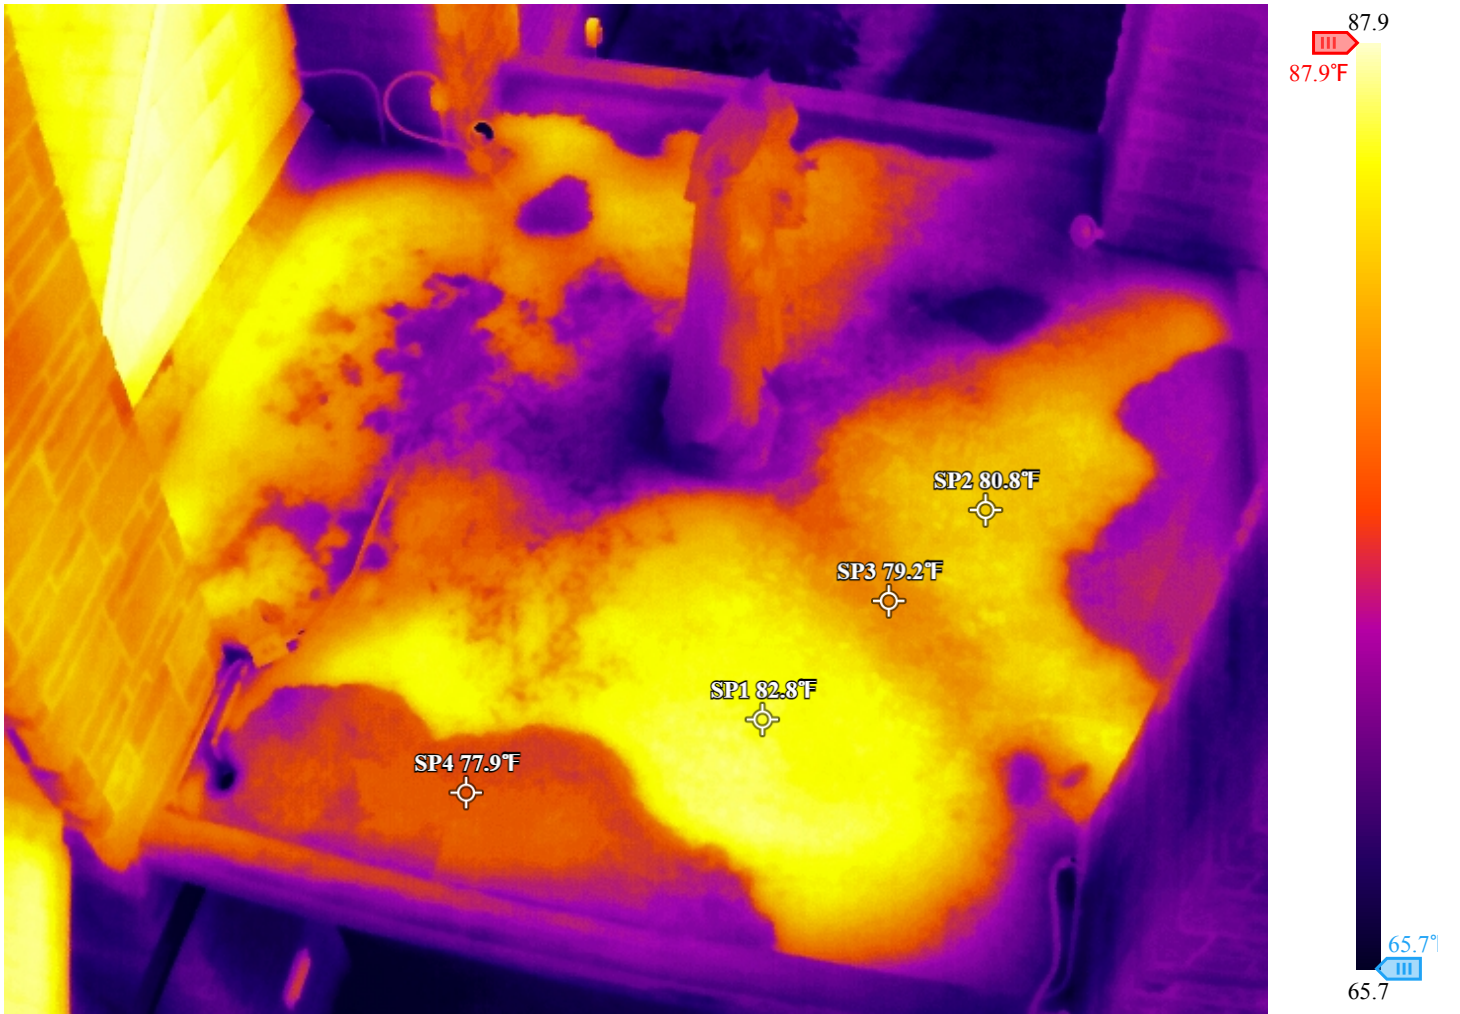
- **Description of Findings:**  
IMG 1 - Standard RGB image - shows standing water accumulations.
- **Potential Issues Identified:**  
There is a possibility of moisture accumulation next to and around the AC unit as the temperatures in the marked areas are higher than areas away from the unit.
- **RGB & Thermal Images: Side 1 Overhang IMG 1**

SP1	VALUE	82.8°F
SP2	VALUE	80.8°F
SP3	VALUE	79.2°F
SP4	VALUE	77.9°F

KEY	VALUE
SP1	Possible Moisture
SP2	Possible Moisture
SP3	Cross Beam
SP4	Surface Water

Image shows areas when water might have penetrated under the paint or in to concrete. See areas in SP1 & SP2.

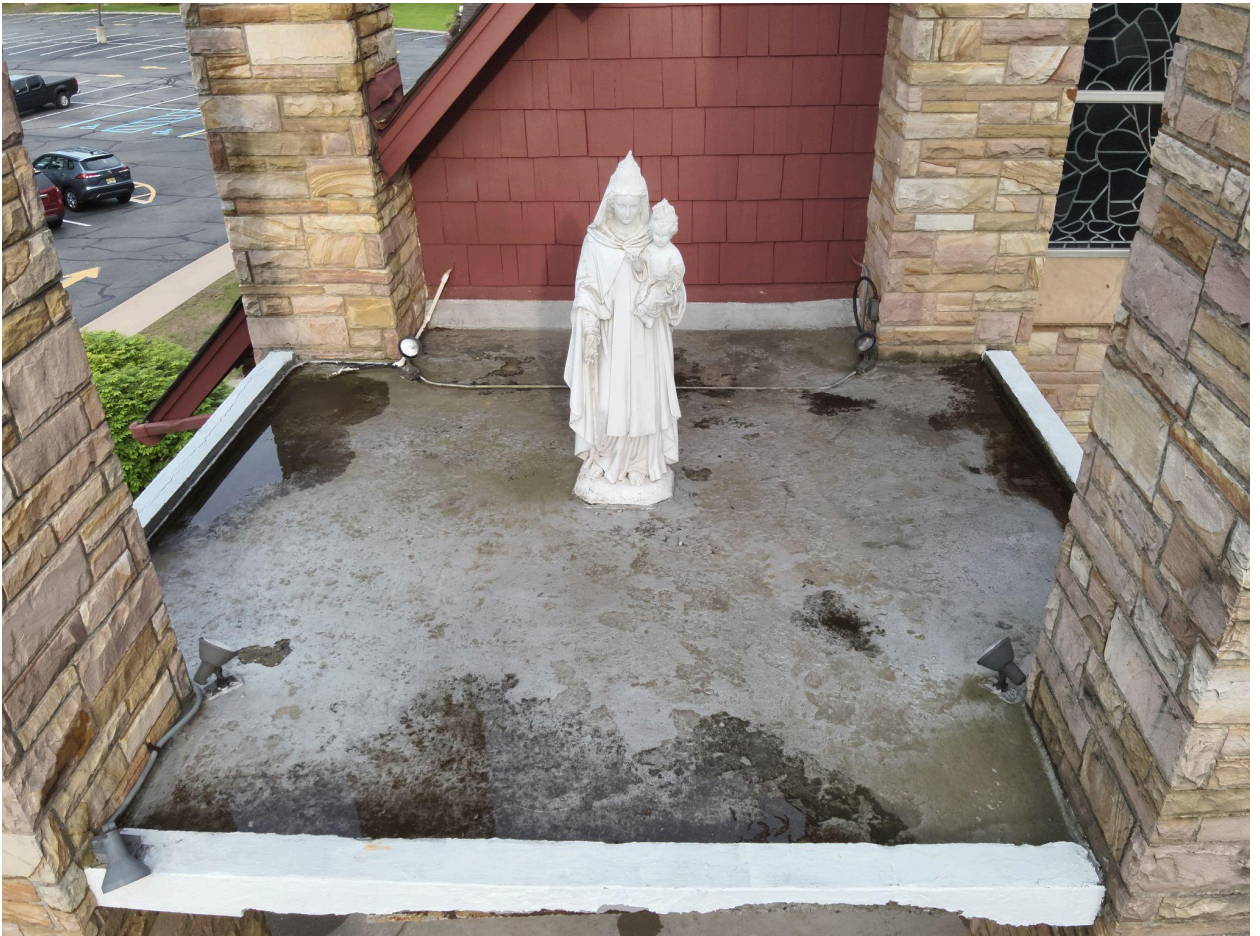
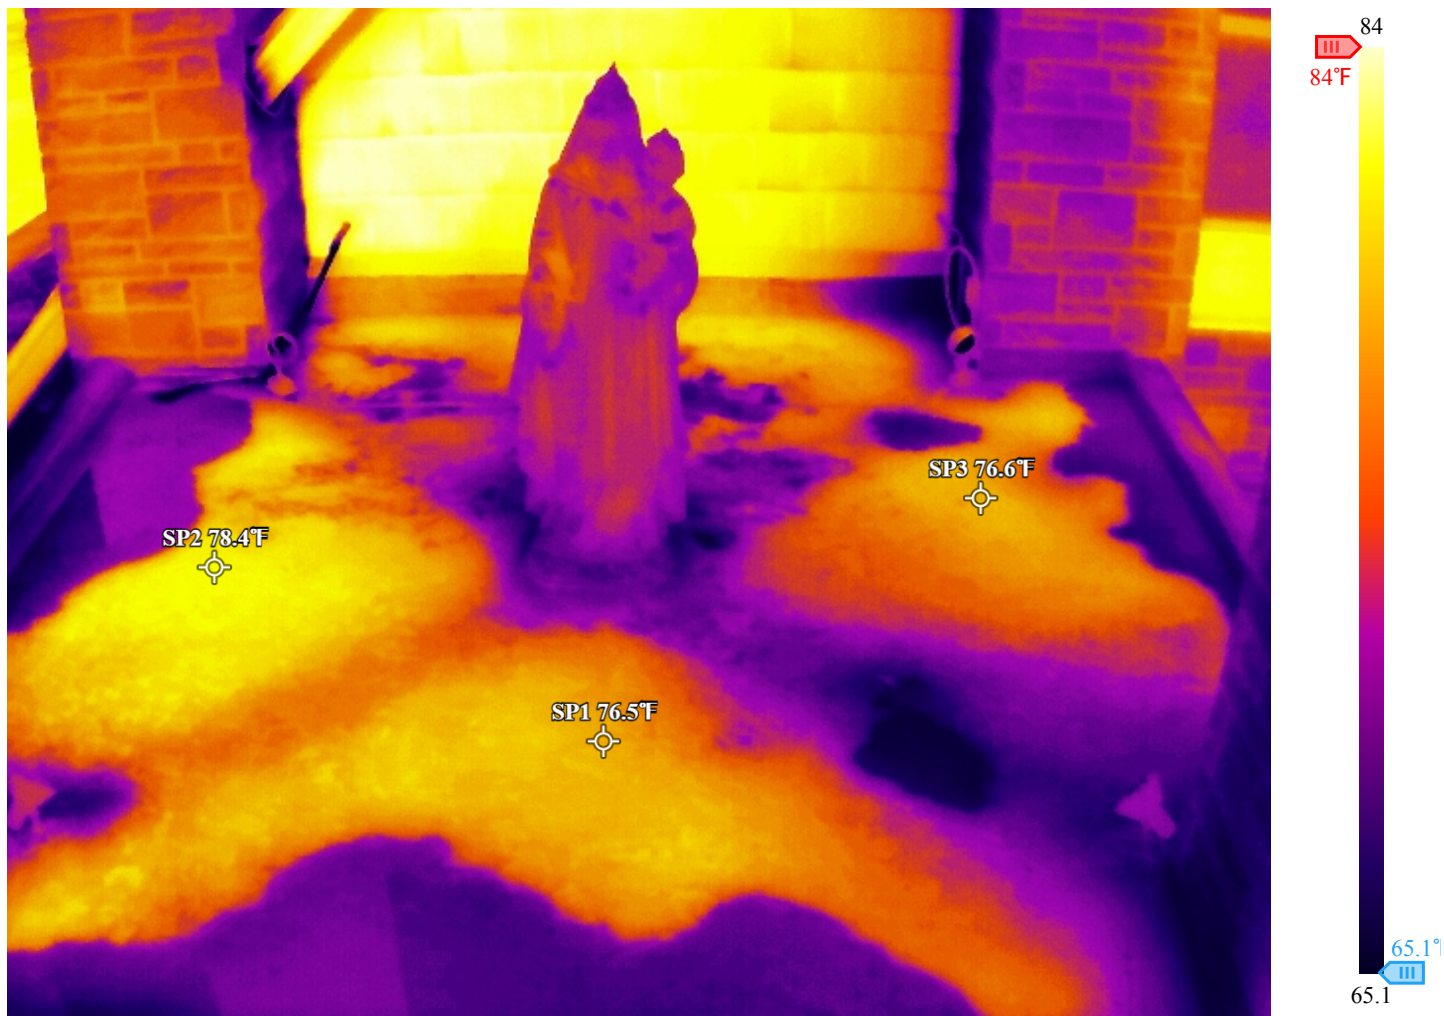
DJI\_20250516181634\_0003\_T.JPG

- **Description of Findings:**  
IMG 3 - The front of the roof, middle section shows a dry area with some standing water on sides.
- **Potential Issues Identified:**  
The thermal image displays areas where moisture might have penetrated underneath the paint and into the concrete.
- **RGB & Thermal Images : Front Overhang Roof IMG 3**

SP1	VALUE	76.5°F
SP2	VALUE	78.4°F
SP3	VALUE	76.6°F

KEY	VALUE
SP1	Possible Moisture
SP2	Possible Moisture
SP3	Possible Moisture

Target areas marked for possible moisture penetration. Can be under surface paint or deeper and should be investigated.

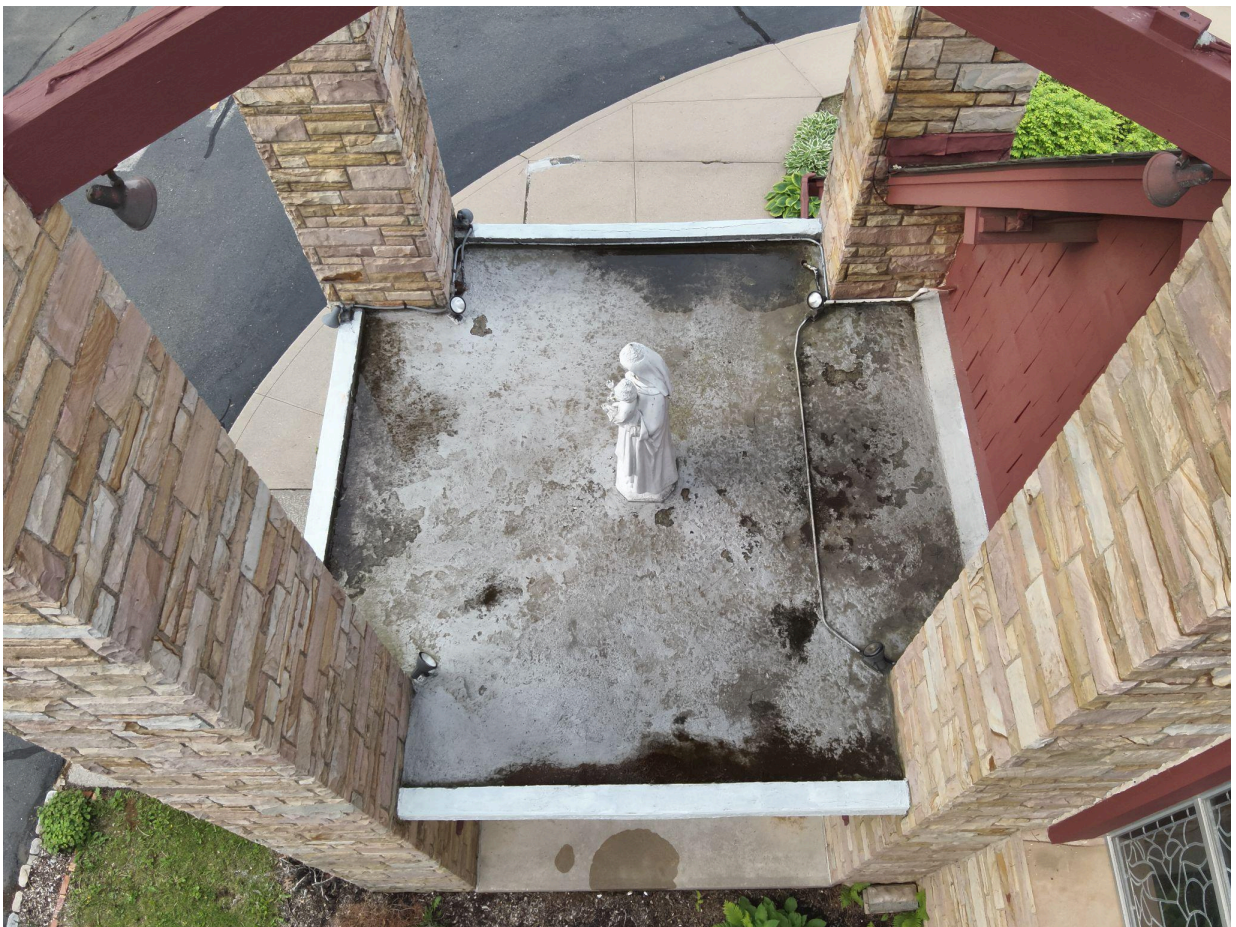
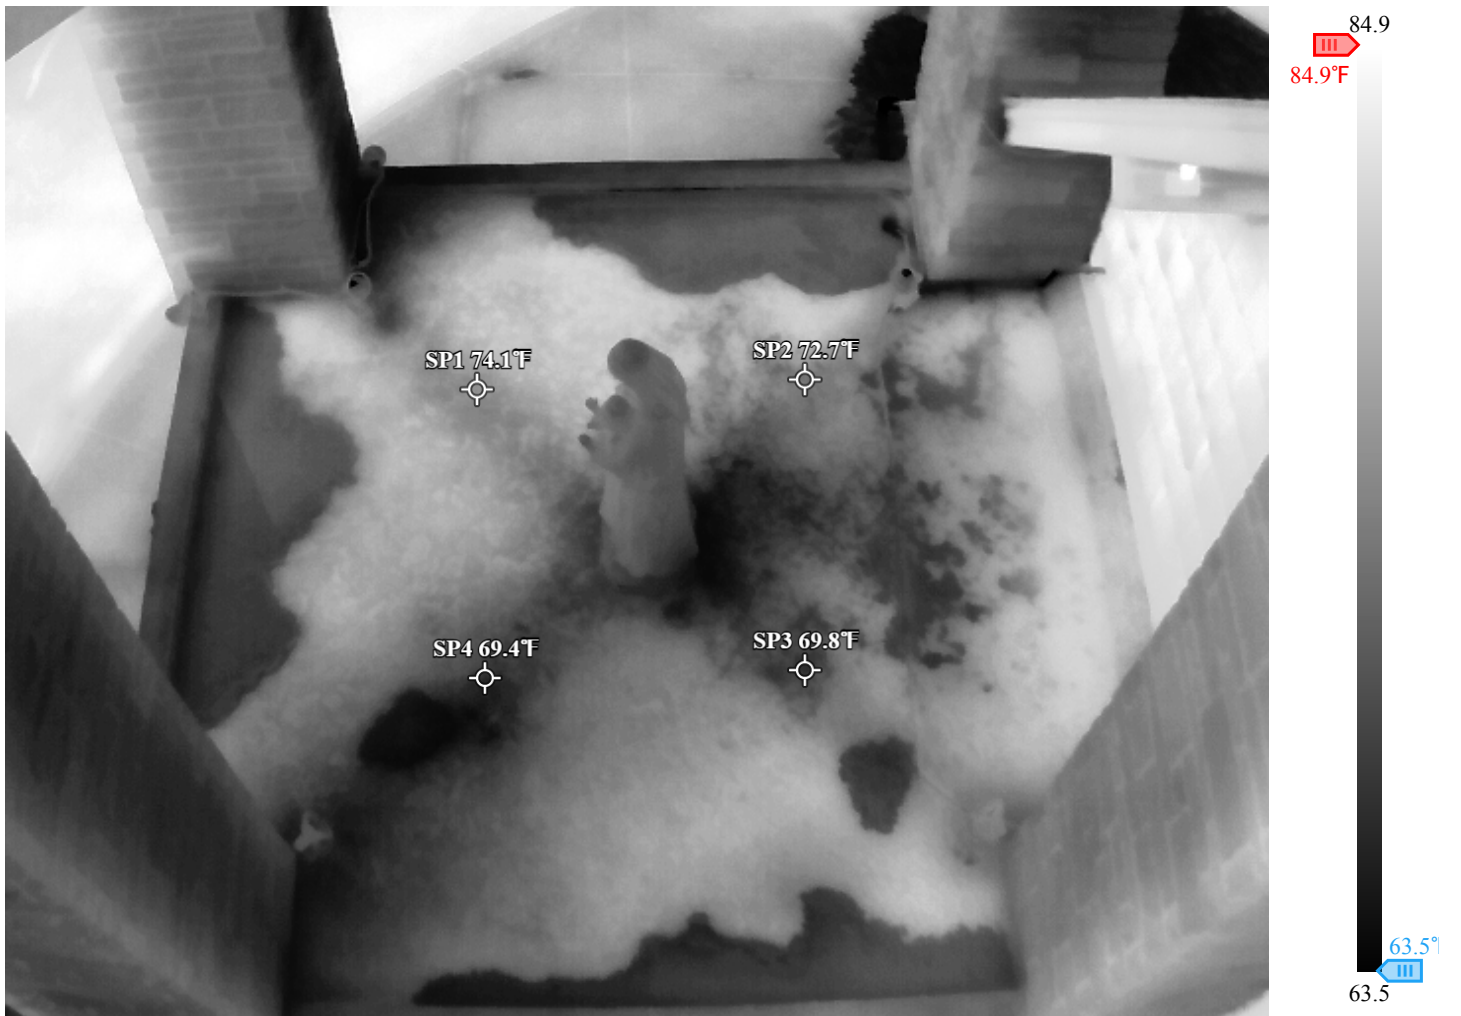
DJI\_20250516181749\_0005\_T.JPG

- **Description of Findings:**  
IMG 5 - Another angle yet at higher altitude to show connecting beams between the pillars.
- **Potential Issues Identified:**  
Beam material is unknown, yet moisture is clearly surrounding the 4 quadrants and can cause deterioration of some type, hence potential hazard.  
**TO BE DETERMINED BY ENGINEERS.**
- **RGB & Thermal Images : Front Overhang Roof IMG 5**

SP1	VALUE	74.1°F
SP2	VALUE	72.7°F
SP3	VALUE	69.8°F
SP4	VALUE	69.4°F

KEY	VALUE
SP1-SP4	Cross Beams

The areas in thermal images that have been identified with marked temperature targets spots show that there is potential water penetration under the paint that clearly has deteriorated allowing for potential water penetration into the structure. Cross beams of unknown material connect the 4 brick pillars. They also might be affected by surrounding moisture and should be looked into by a structural engineer.
